Campus Modernization

Condition and Space Analysis

Patterson Hall Modernization

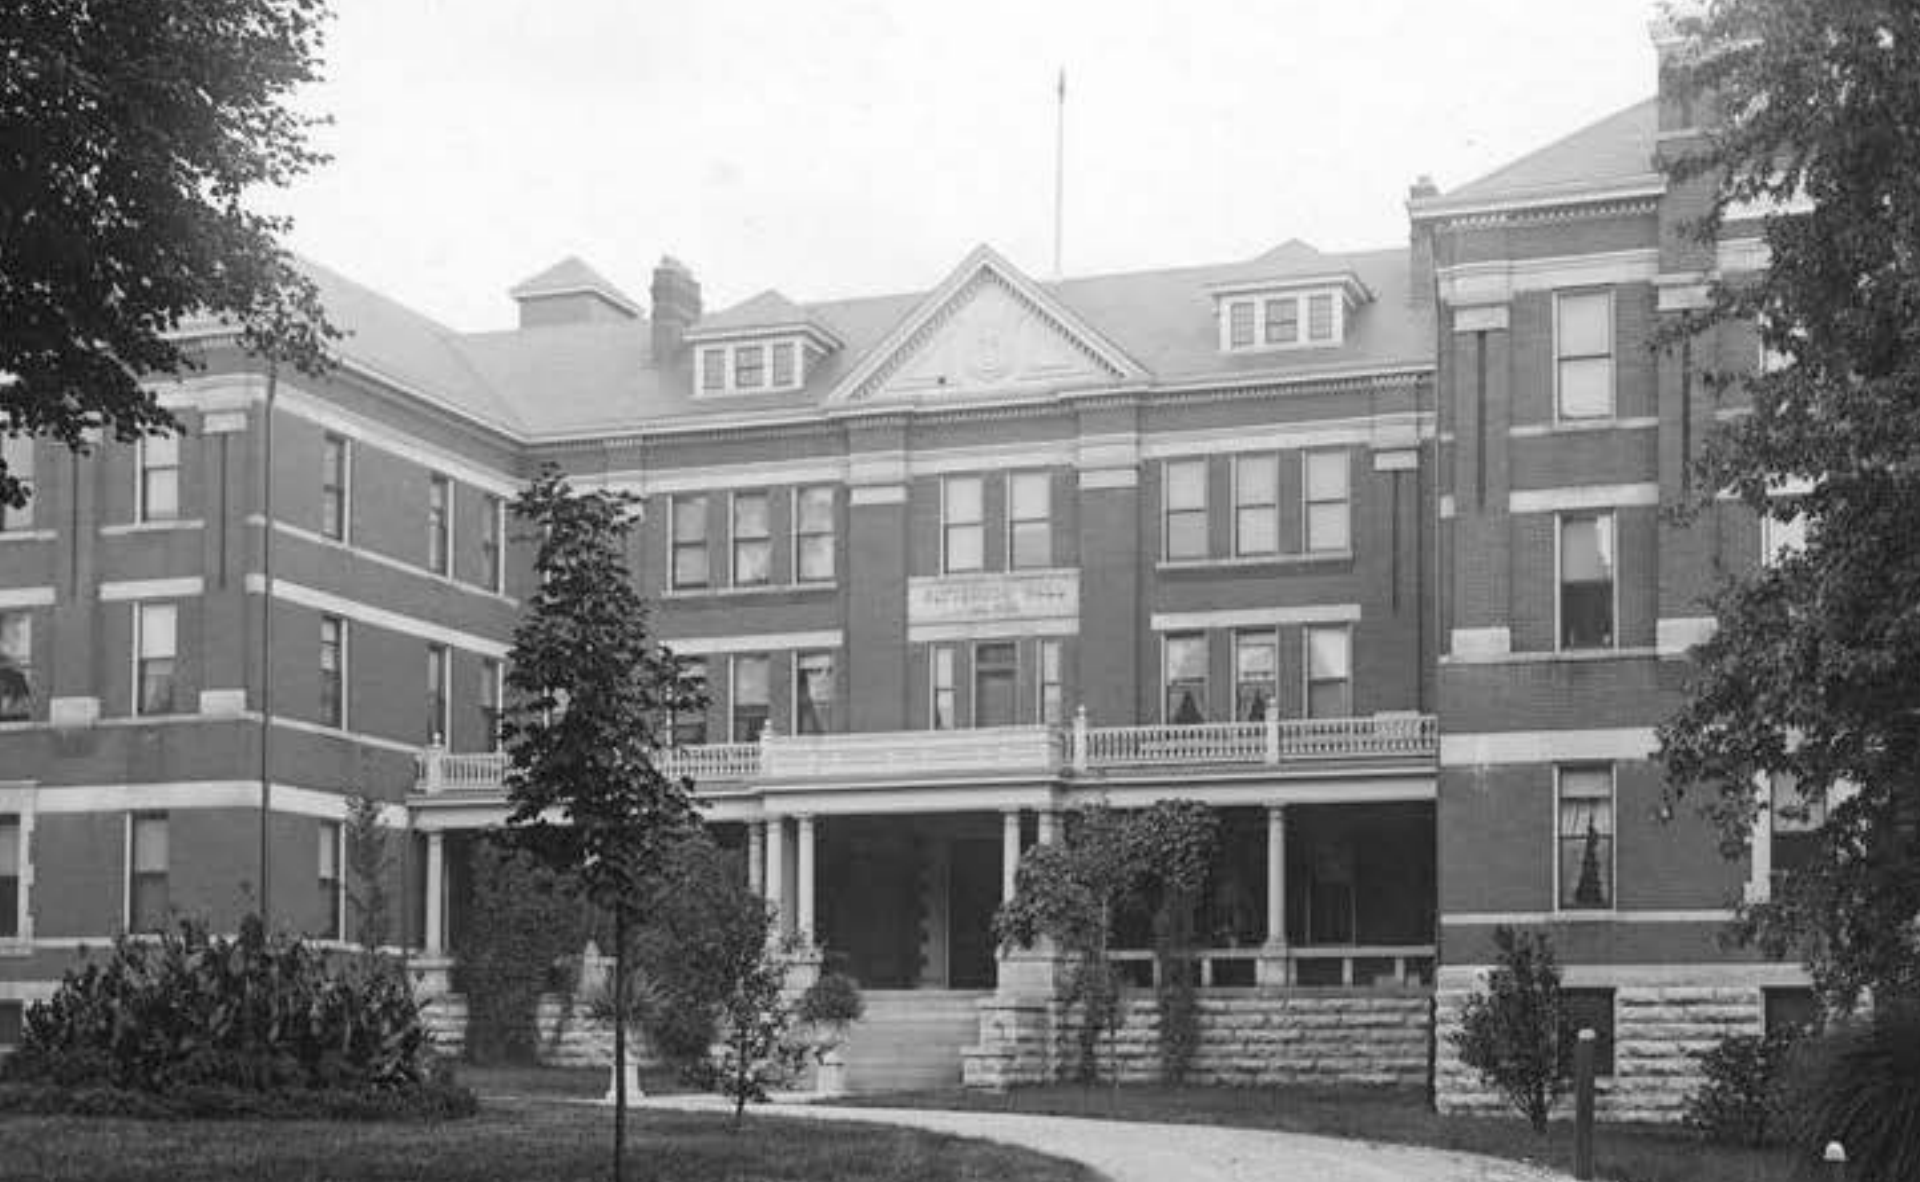
Patterson Hall Rehabilitation

- Constructed in 1904.
- First Women's Residence Hall.
- Repurpose the space.
- Facility Condition Index.
 - Although an FCI was not calculated for this building, in comparison to other buildings of similar vintage the FCI would be approximately 50 – 60%.

- Replace the windows
- Restore the cornice
- Restore the second floor porch
- Repoint the brick
- Rehabilitate the masonry
- Make front door accessible to those with disabilities
- Rebuild stair towers at rear

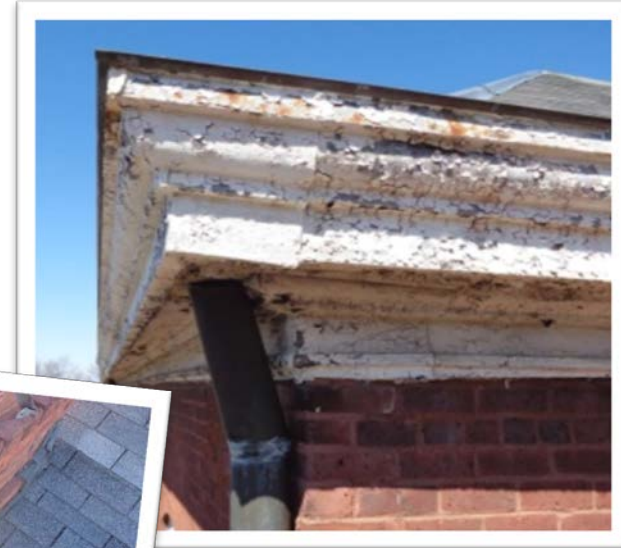
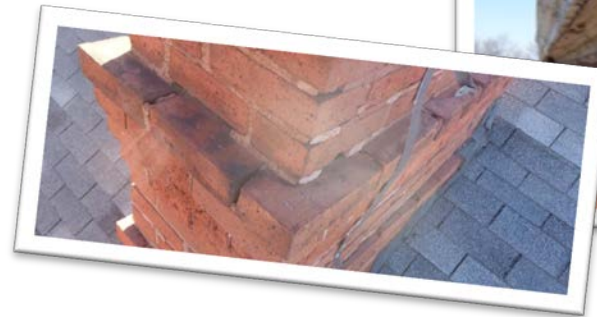
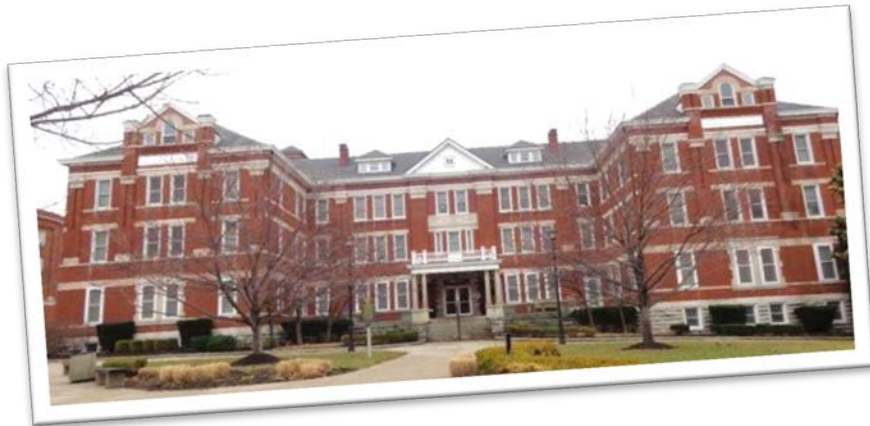
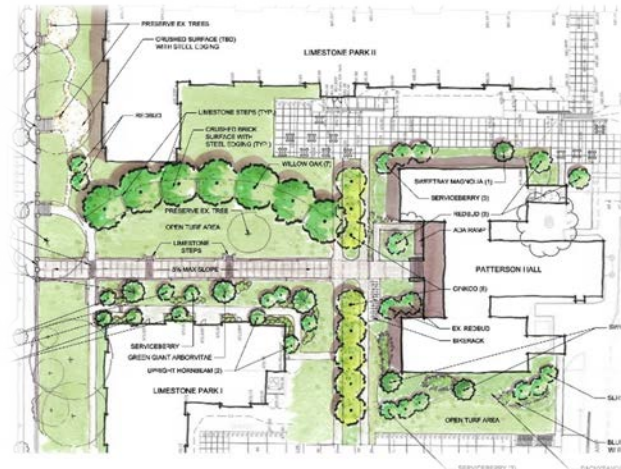
Patterson Hall Modernization

EXTERIOR:

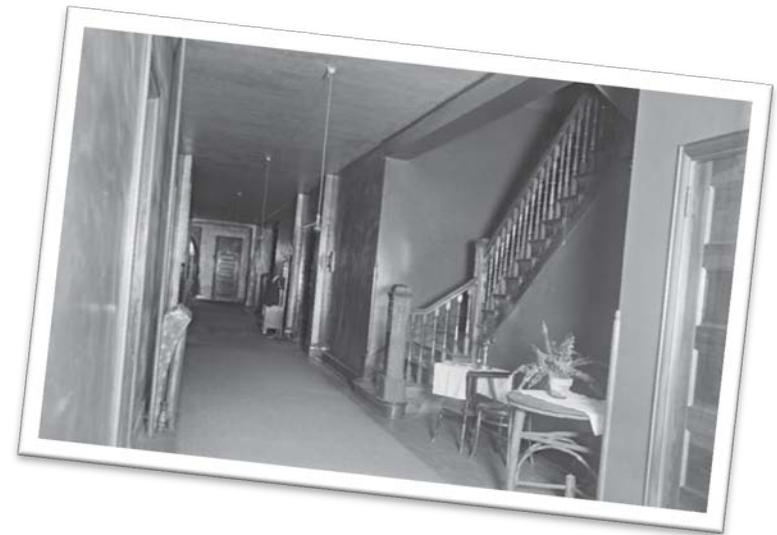
Patterson Hall Modernization

INTERIOR

- Create classrooms, study lounges, offices and study rooms for students.
- House 3 visiting scholars.
- Reuse the central ballroom.
- Restore the exterior second floor porch.
- Maintain high ceiling heights.
- Refinish wood trim, floor and doors.
- Restore the main corridor.
- Refinish the historic doors.
- Install new lighting.
- Rehang doors.
- Maintain window transoms.
- Restore pressed tin ceiling.
- Clean up systems distribution.

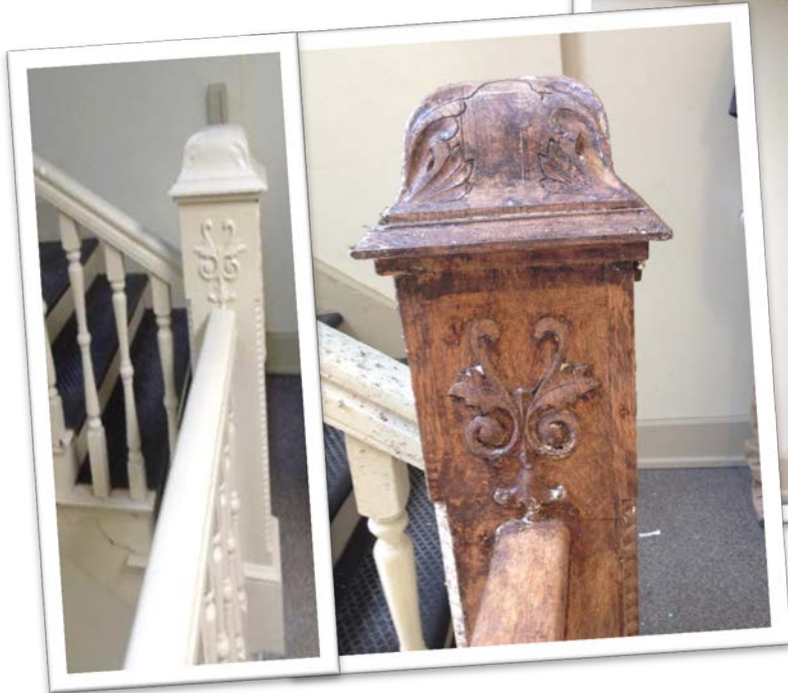
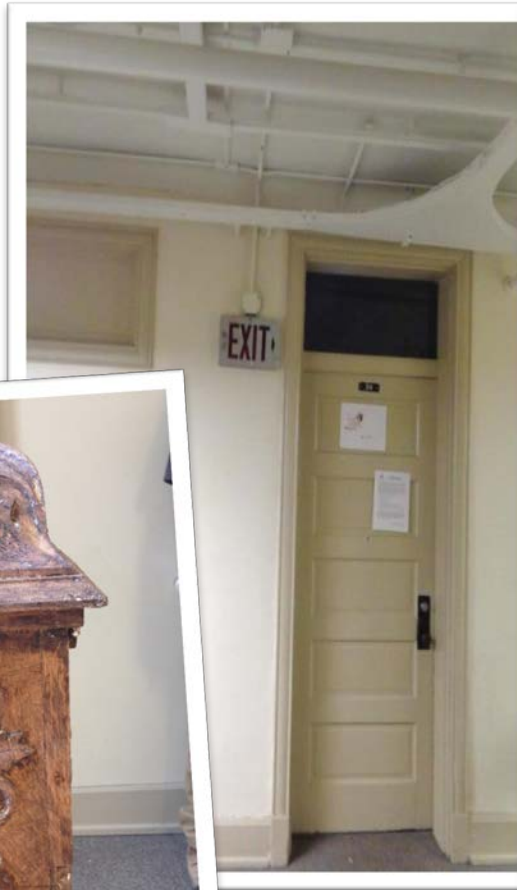
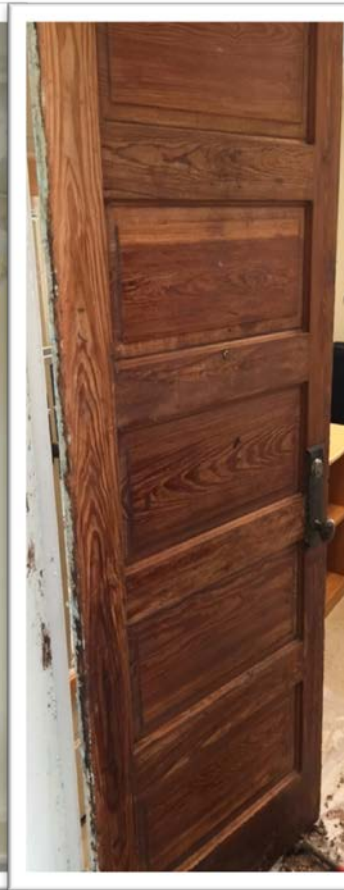
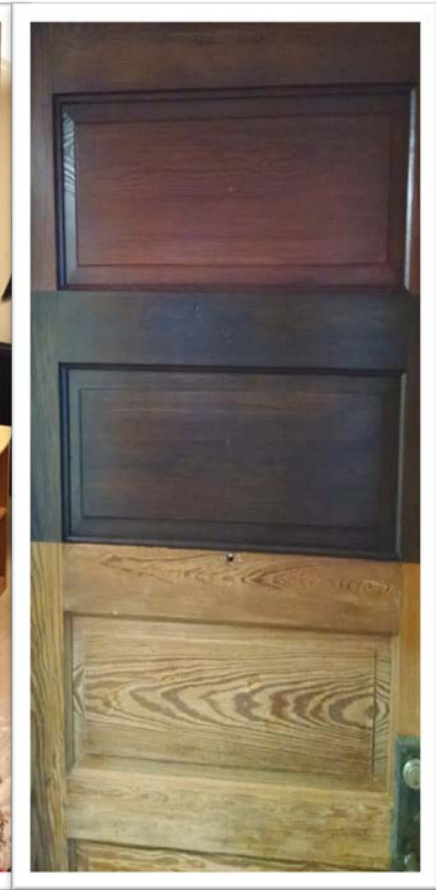
Patterson Hall Modernization

Constructed in 1904
